Manhole Inspection Summary

Manhole # S11Q__008MH

Insp Date: **4/17/08 1:05 PM**

Location Address: **3101 Strickland St**

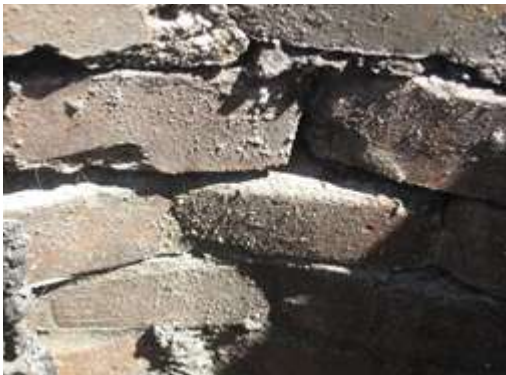
Defect 3

Condition: ☐ Sound ☐ Cracked ☐ Root Intrusion ☒ **Loose Brick** ☐ Deteriorated

Loose bricks and mortar in barrel

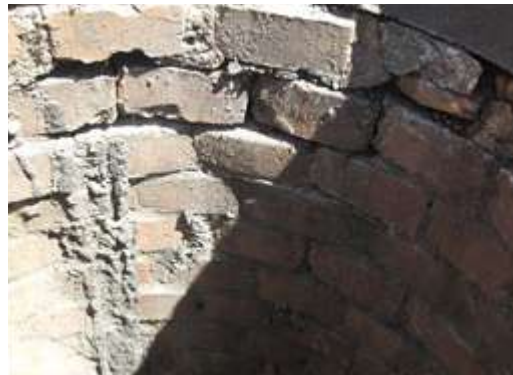
Defect 2

Condition: ☐ Sound ☐ Cracked ☐ Root Intrusion ☒ **Loose Brick** ☐ Deteriorated

Infiltration: ☐ None ☐ Joint ☐ Cracks ☐ Mortar ☐ Roots ☒ **Wall**

Loose bricks and mortar in chimney/evidence of infiltration

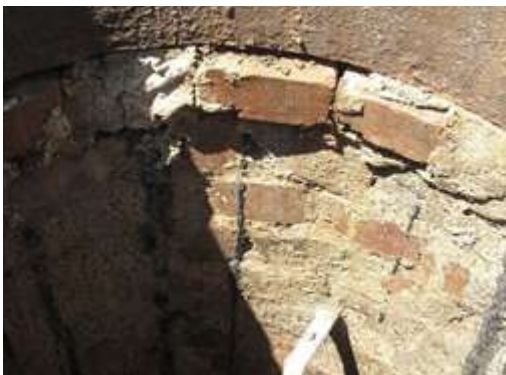
Defect 1

Loose bricks and mortar under frame

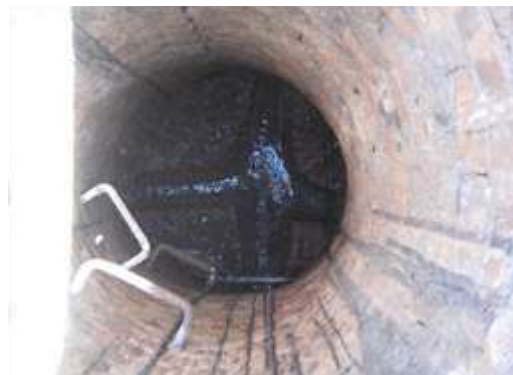
Defect 5

Count: **5** Missing: **0** ☒ **Corroded**

steps corroded

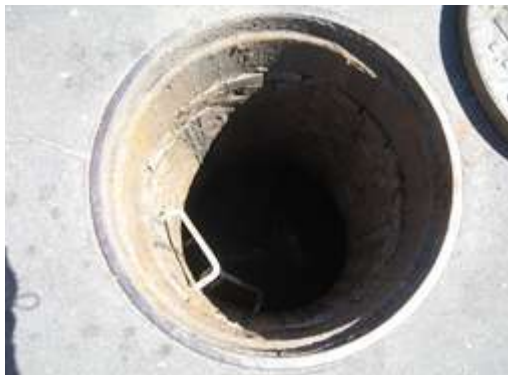
Defect 4

☒ **Leaks**

Frame leaks

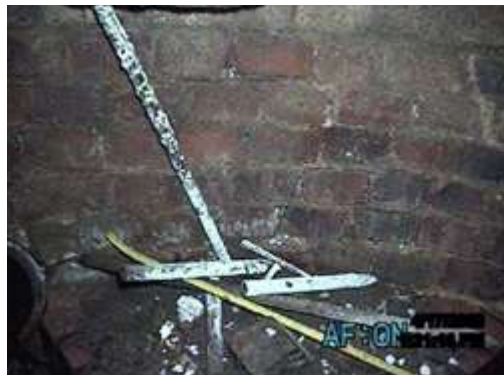
Defect 6

Condition: ☐ Sound ☐ Cracked ☐ Root Intrusion ☐ Deteriorated ☐ Leaks ☒ **Debris**

Debris on bench
